No. 1573

FLIGHT MEASUREMENTS OF THE FLYING QUALITIES OF
FIVE LIGHT AIRPLANES

By Paul A. Hunter

Langley Memorial Aeronautical Laboratory
Langley Field, Va.

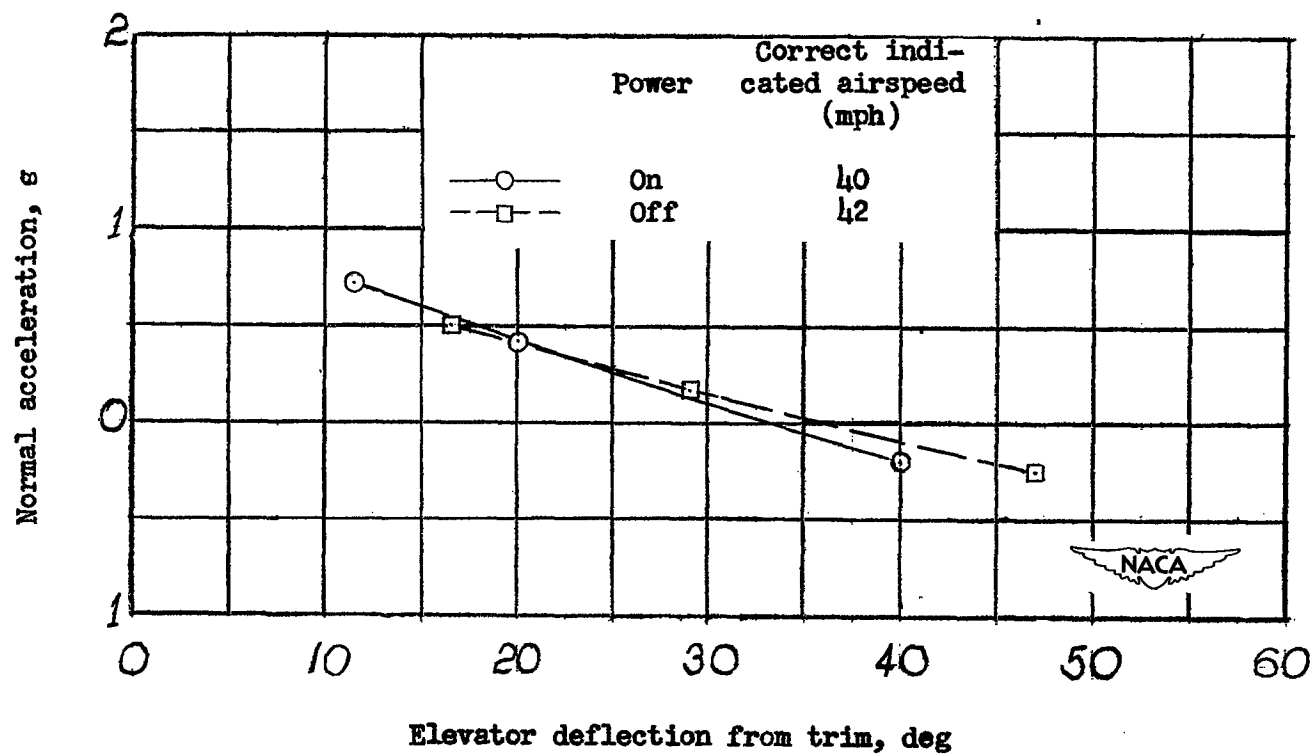
Figure 12.- Normal accelerations produced in abrupt push-downs at speeds close to stall.
Airplane 1.

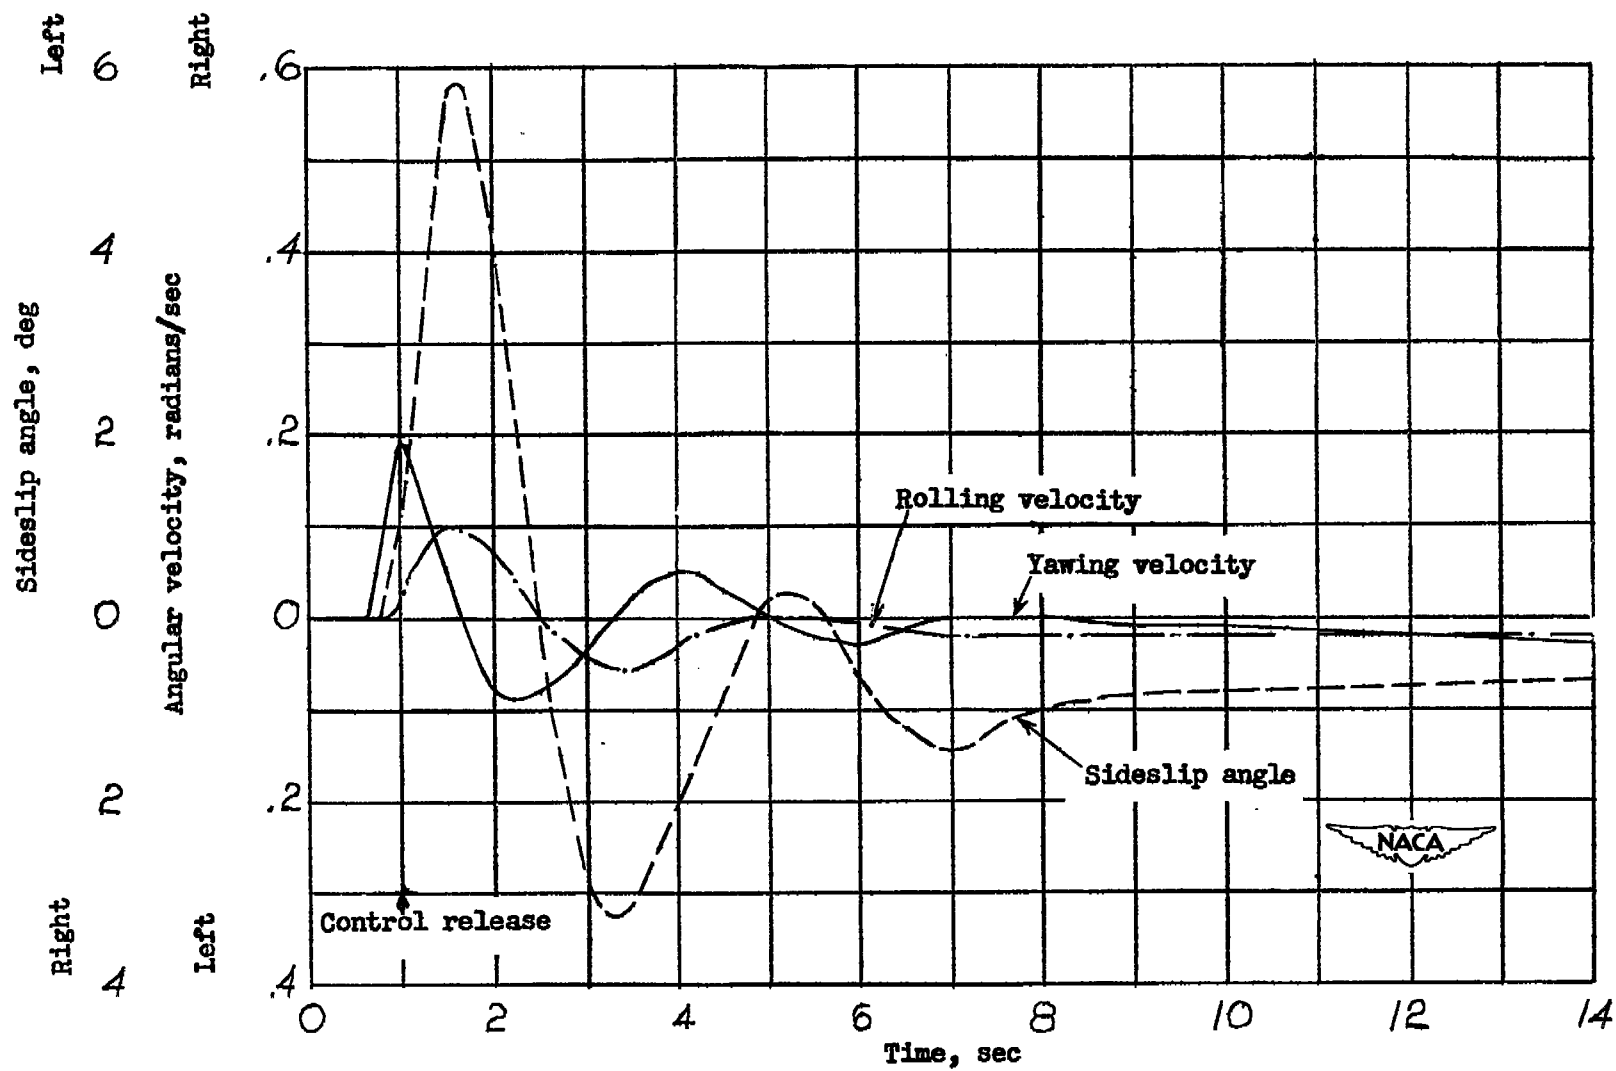
Figure 13.- Relation between yawing velocity, rolling velocity, and sideslip angle in a typical lateral oscillation with power on and flaps up. Airplane 4.

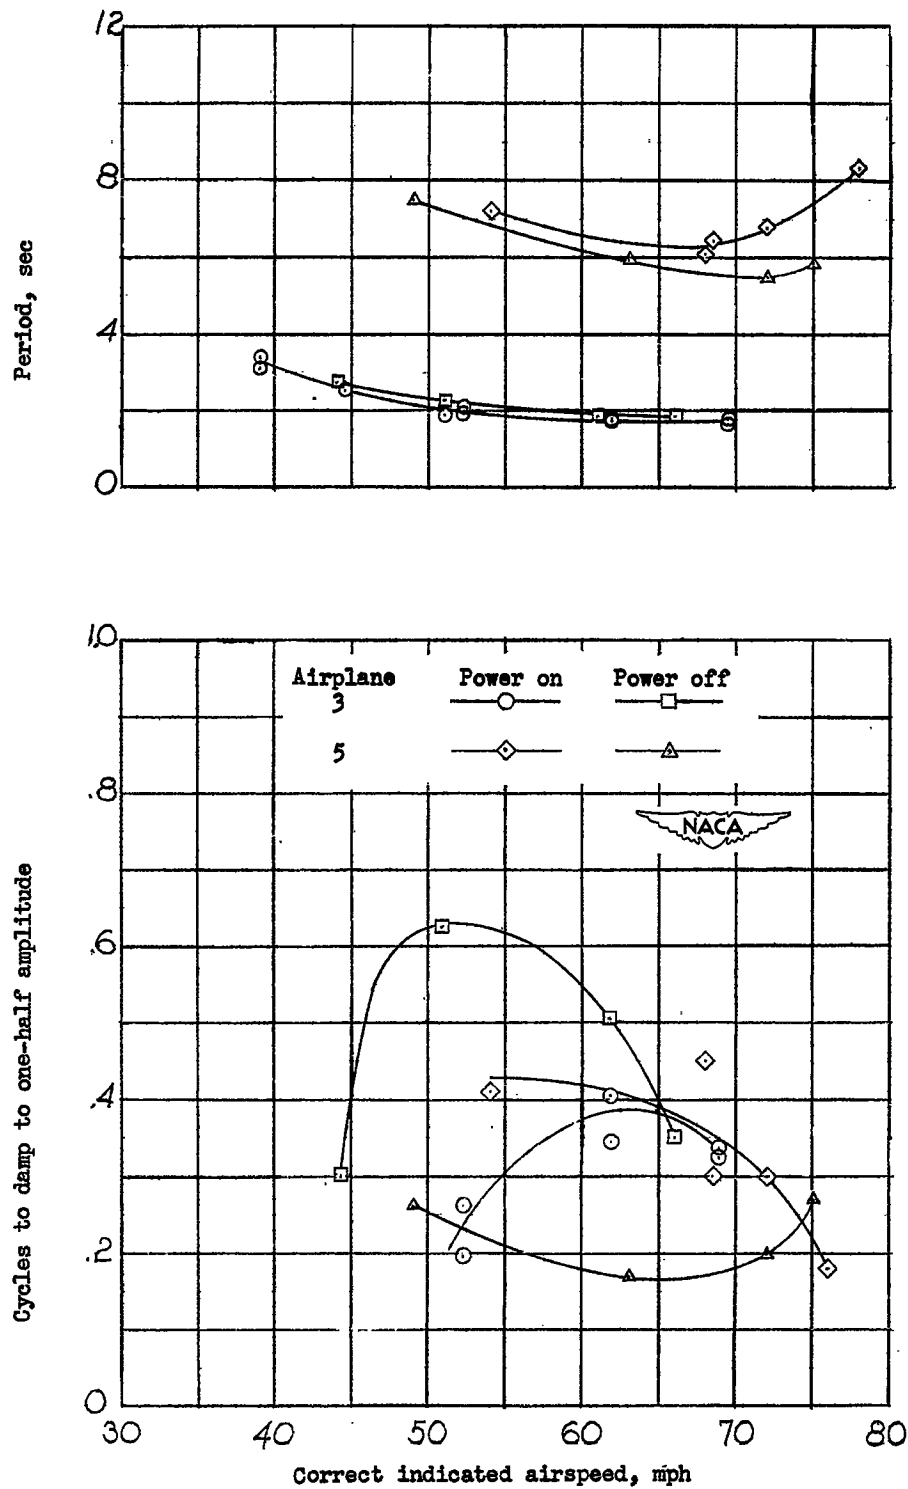
Figure 14.- Period and damping characteristics for lateral oscillations. Airplanes 3 and 5.

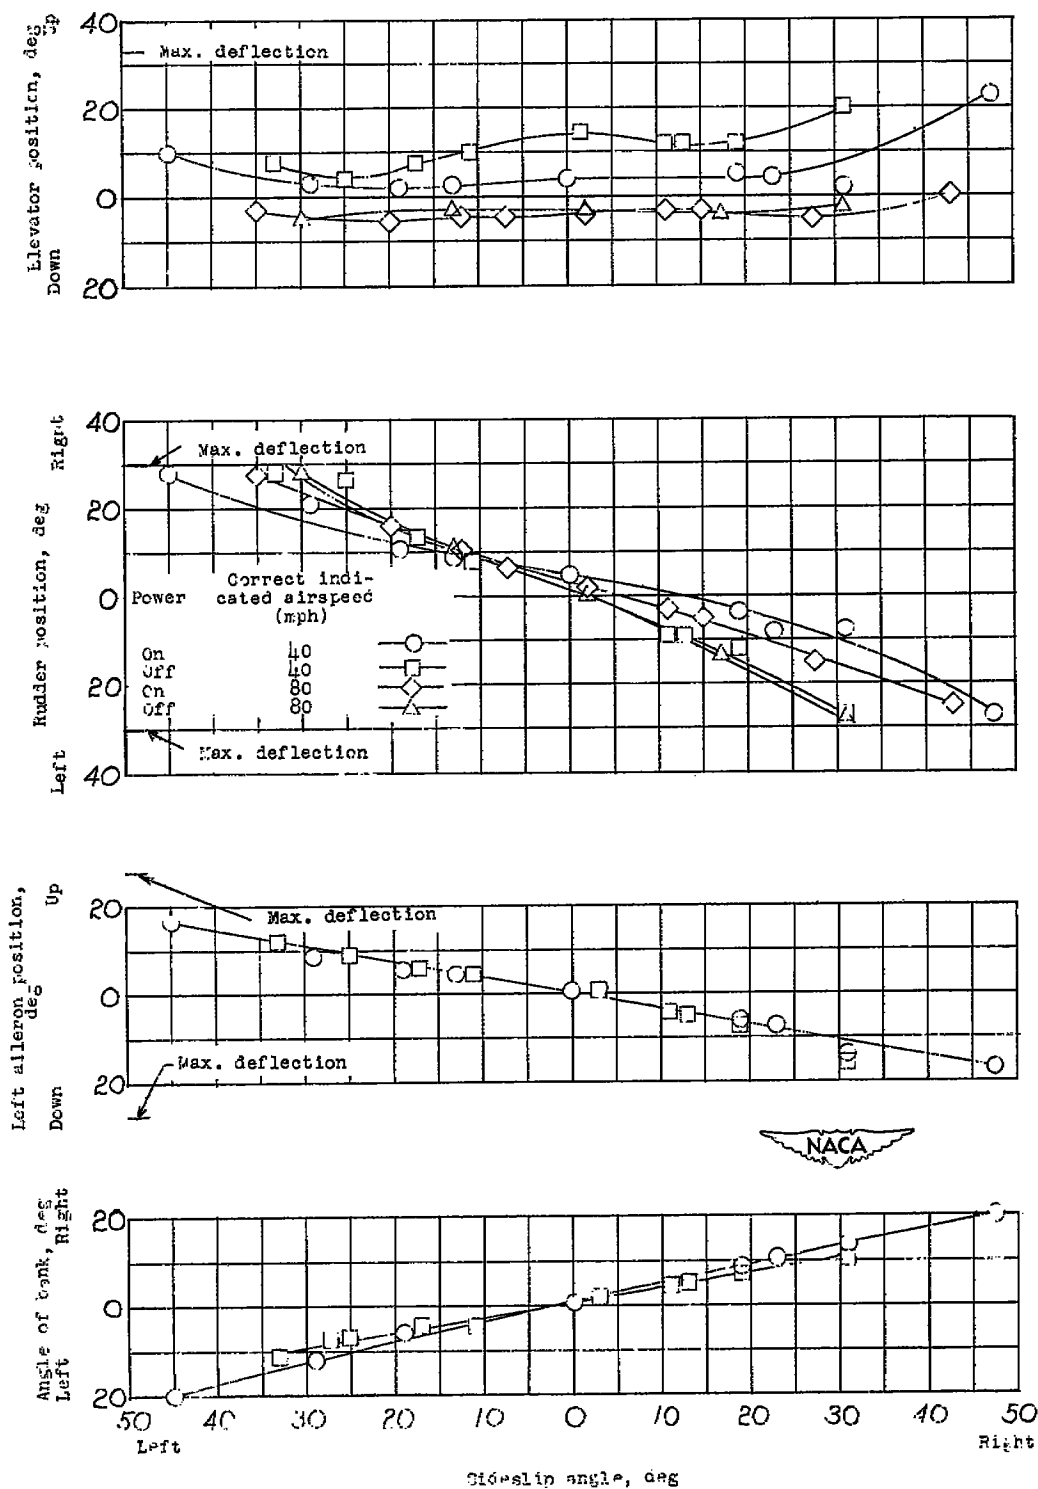
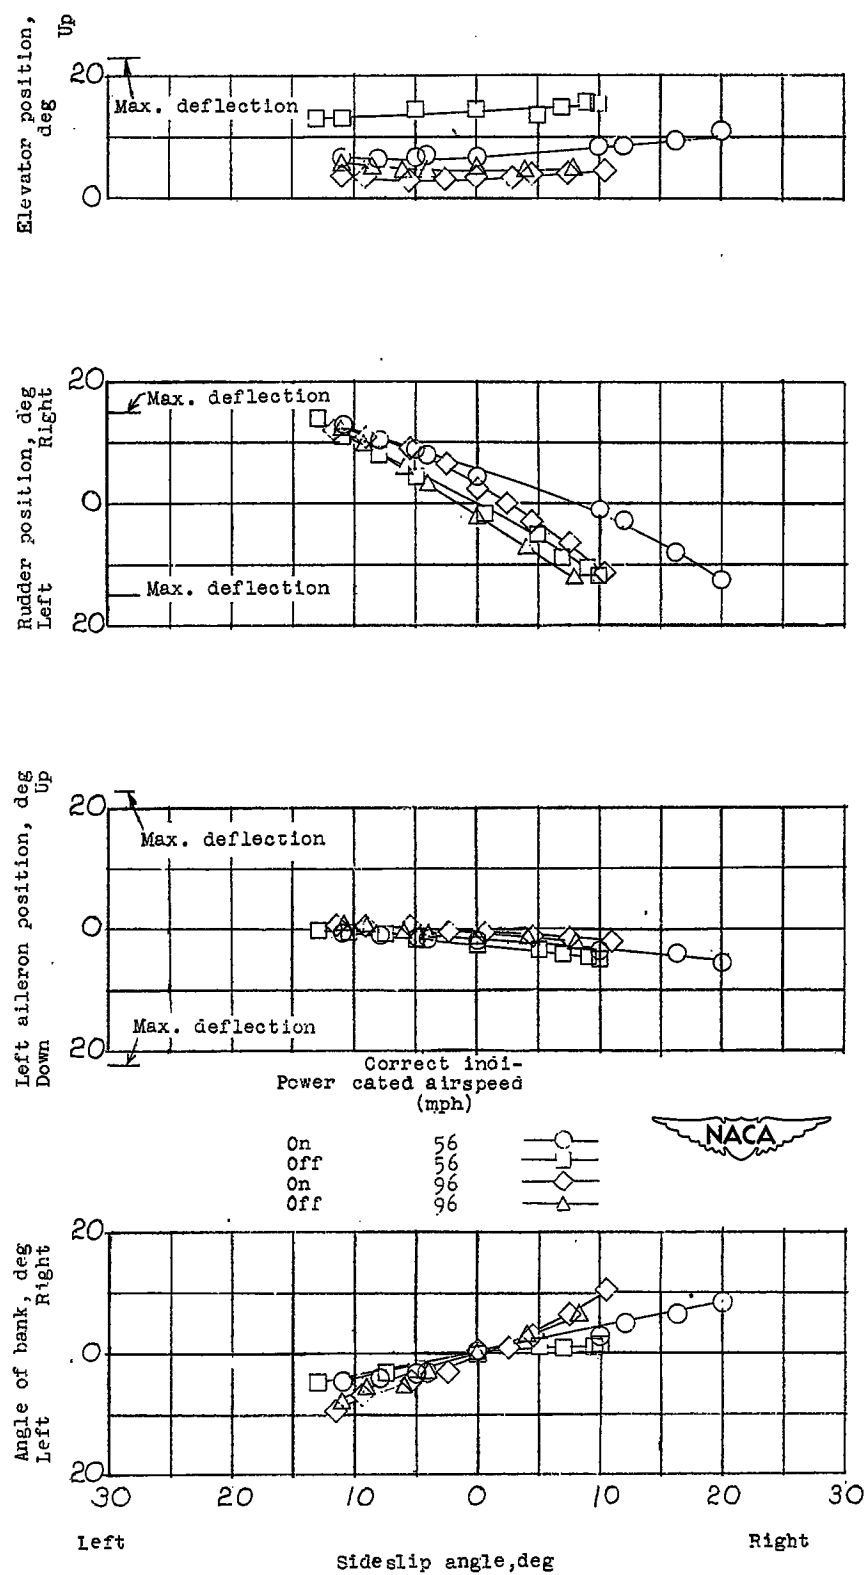
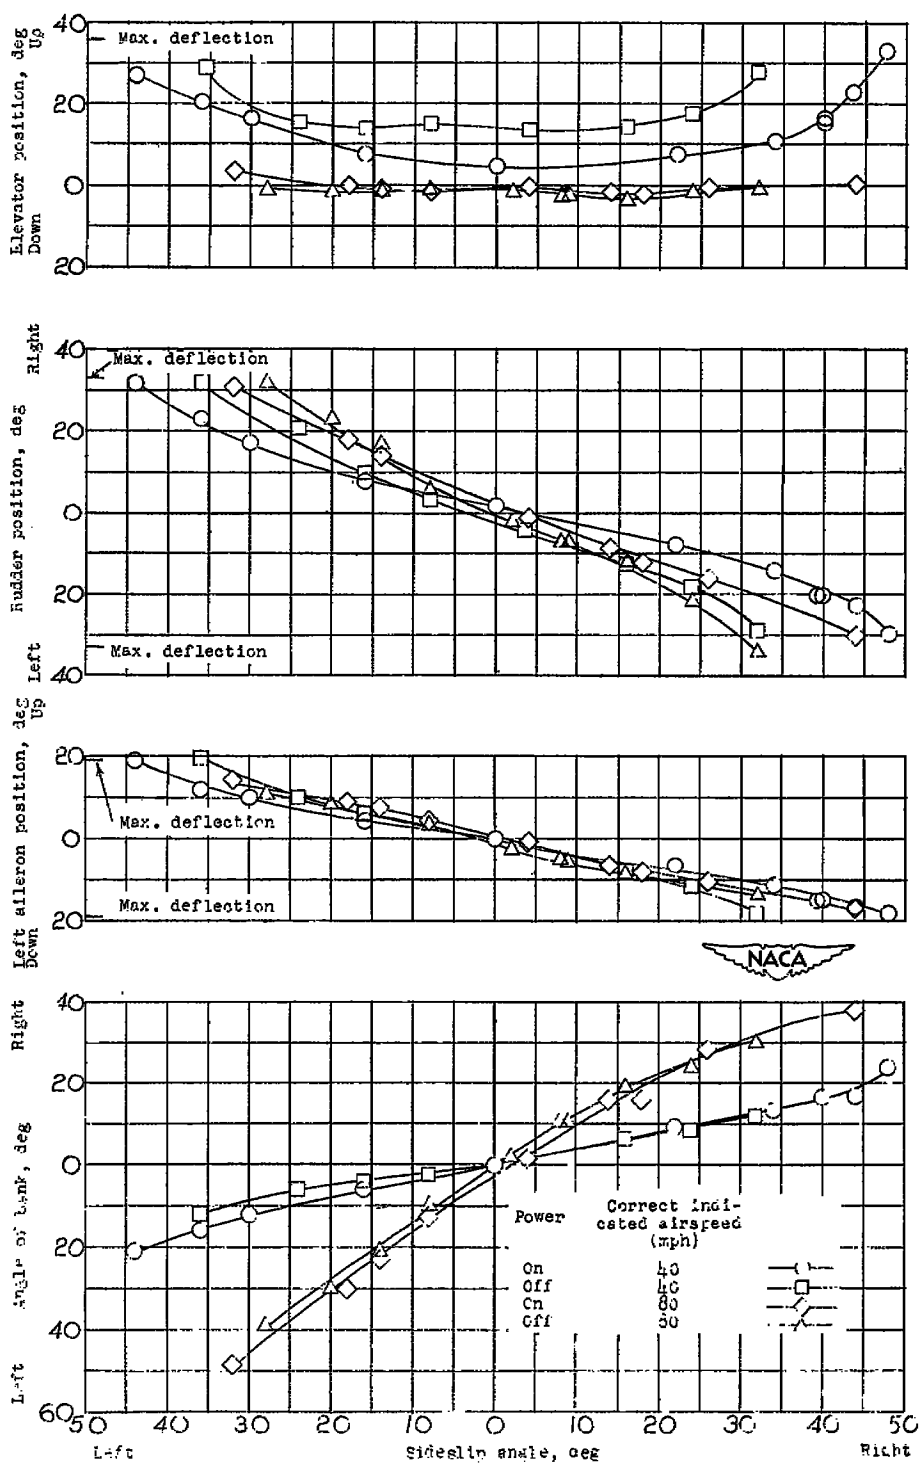
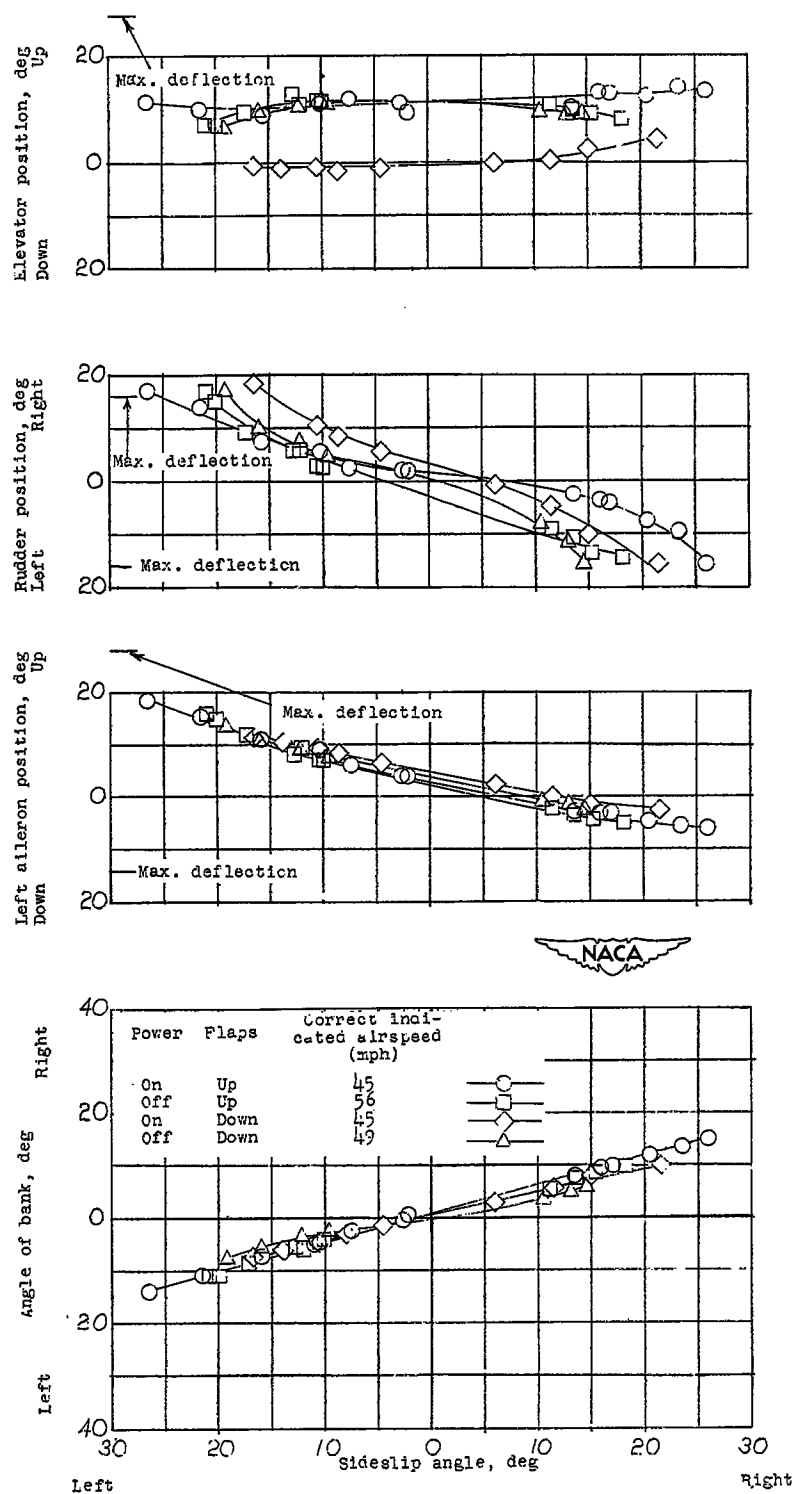
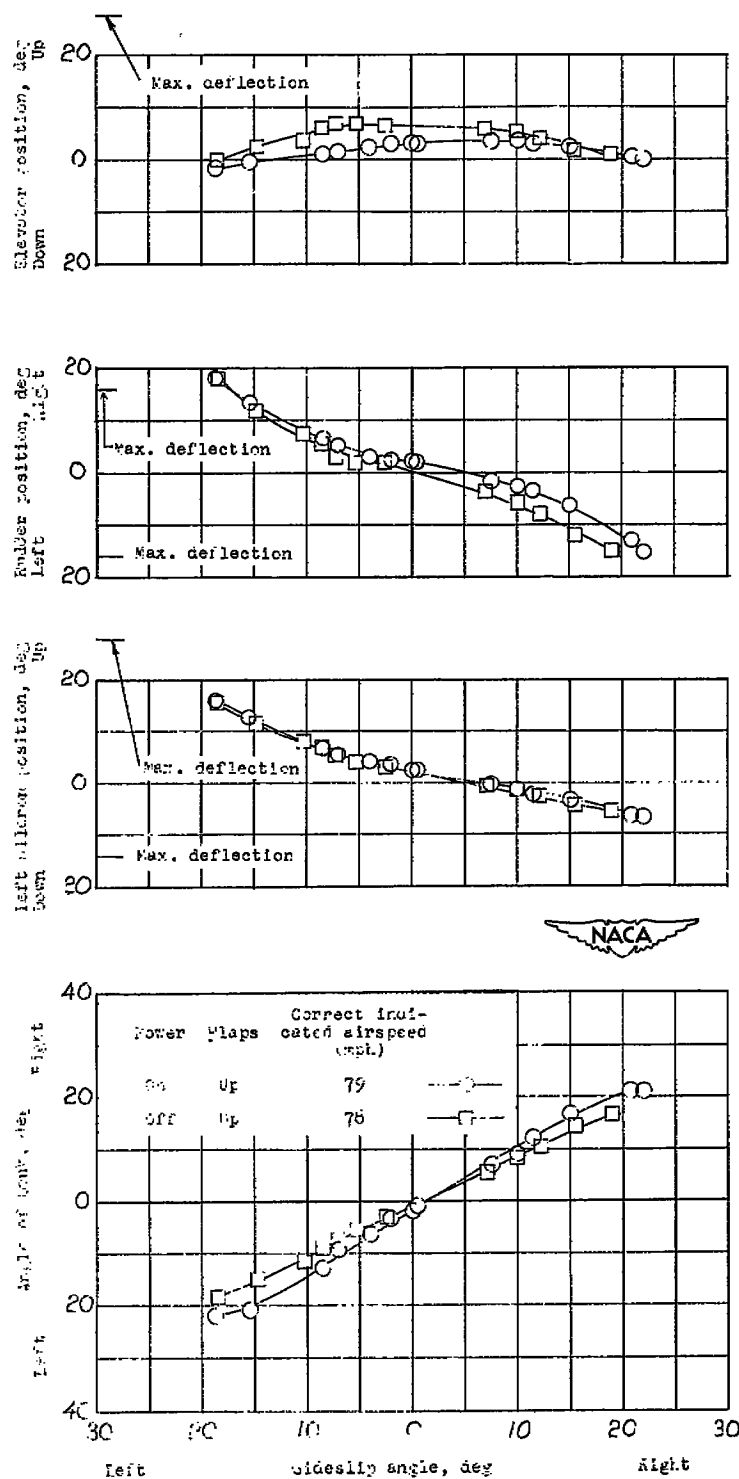
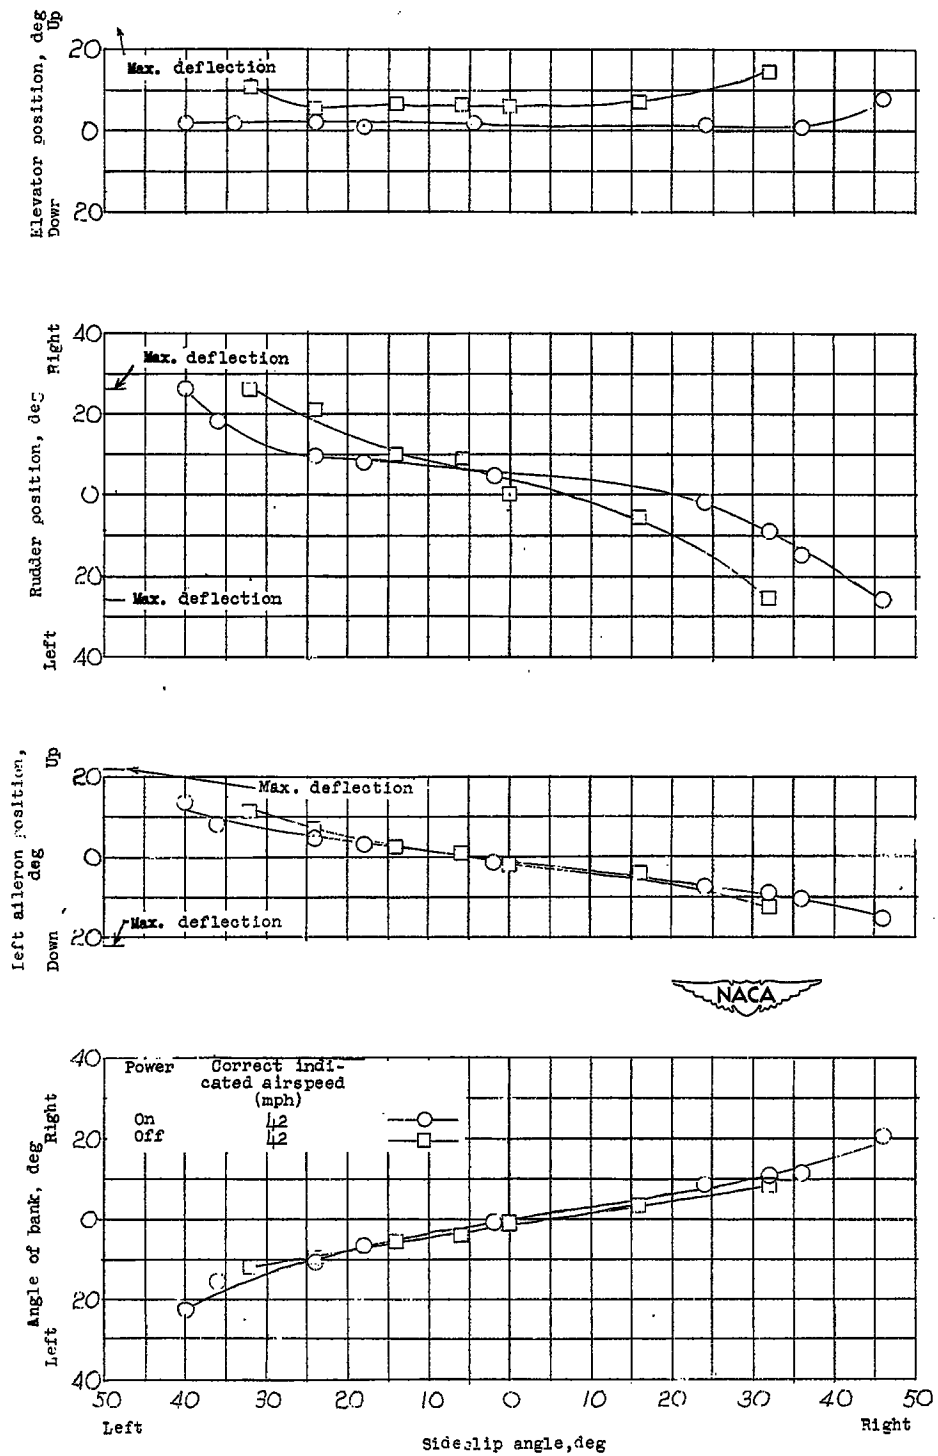
Figure 15.- Sideslip characteristics. Airplane 1.

Figure 16.- Sideslip characteristics. Landing gear down; airplane 2.

Figure 17.- Sideslip characteristics. Airplane 3.

Figure 18.- Sideslip characteristics. Airplane 4.

Figure 19.- Sideslip characteristics. Airplane 5.

for example, during recovery from an improperly coordinated turn. Figures 15 to 19 show that considerable differences in pitching-moment characteristics existed among these five airplanes although the change in pitching moment with sideslip was generally desirably small. In most cases the pitching moment was such as to cause the airplane to nose down at large sideslip angles although some airplanes which were in this classification also showed a tendency to nose up at small angles of sideslip. These two characteristics may be seen in figure 15 for airplane 1 in the power-on low-speed and power-off low-speed conditions, respectively. Airplane 4 in most cases tended to pitch up at large angles of sideslip, as may be seen in figure 18. Unsymmetrical pitching-moment characteristics are shown in figure 15 for airplane 1 in the power-off high-speed condition and in figure 19 for airplane 5 in the power-off low-speed condition. This type of characteristic is not particularly dangerous but is somewhat unusual in the power-off condition. The particular pitching-moment characteristic noted in the low-speed condition for a given configuration and airplane was generally encountered also at the higher speeds but the magnitudes were smaller. Airplane 2 showed little change in pitching moment with sideslip angle relative to that of the other airplanes, mainly because of the small sideslip angle attainable with this airplane. Because these tests were made by keeping the pilot's airspeed meter reading constant, these data are not entirely satisfactory, since considerable error was introduced in the airspeed system by sideslip on the pitot-static head. Partial stalling may have occurred during the low-speed power-off sideslips and may have introduced further error in the data.

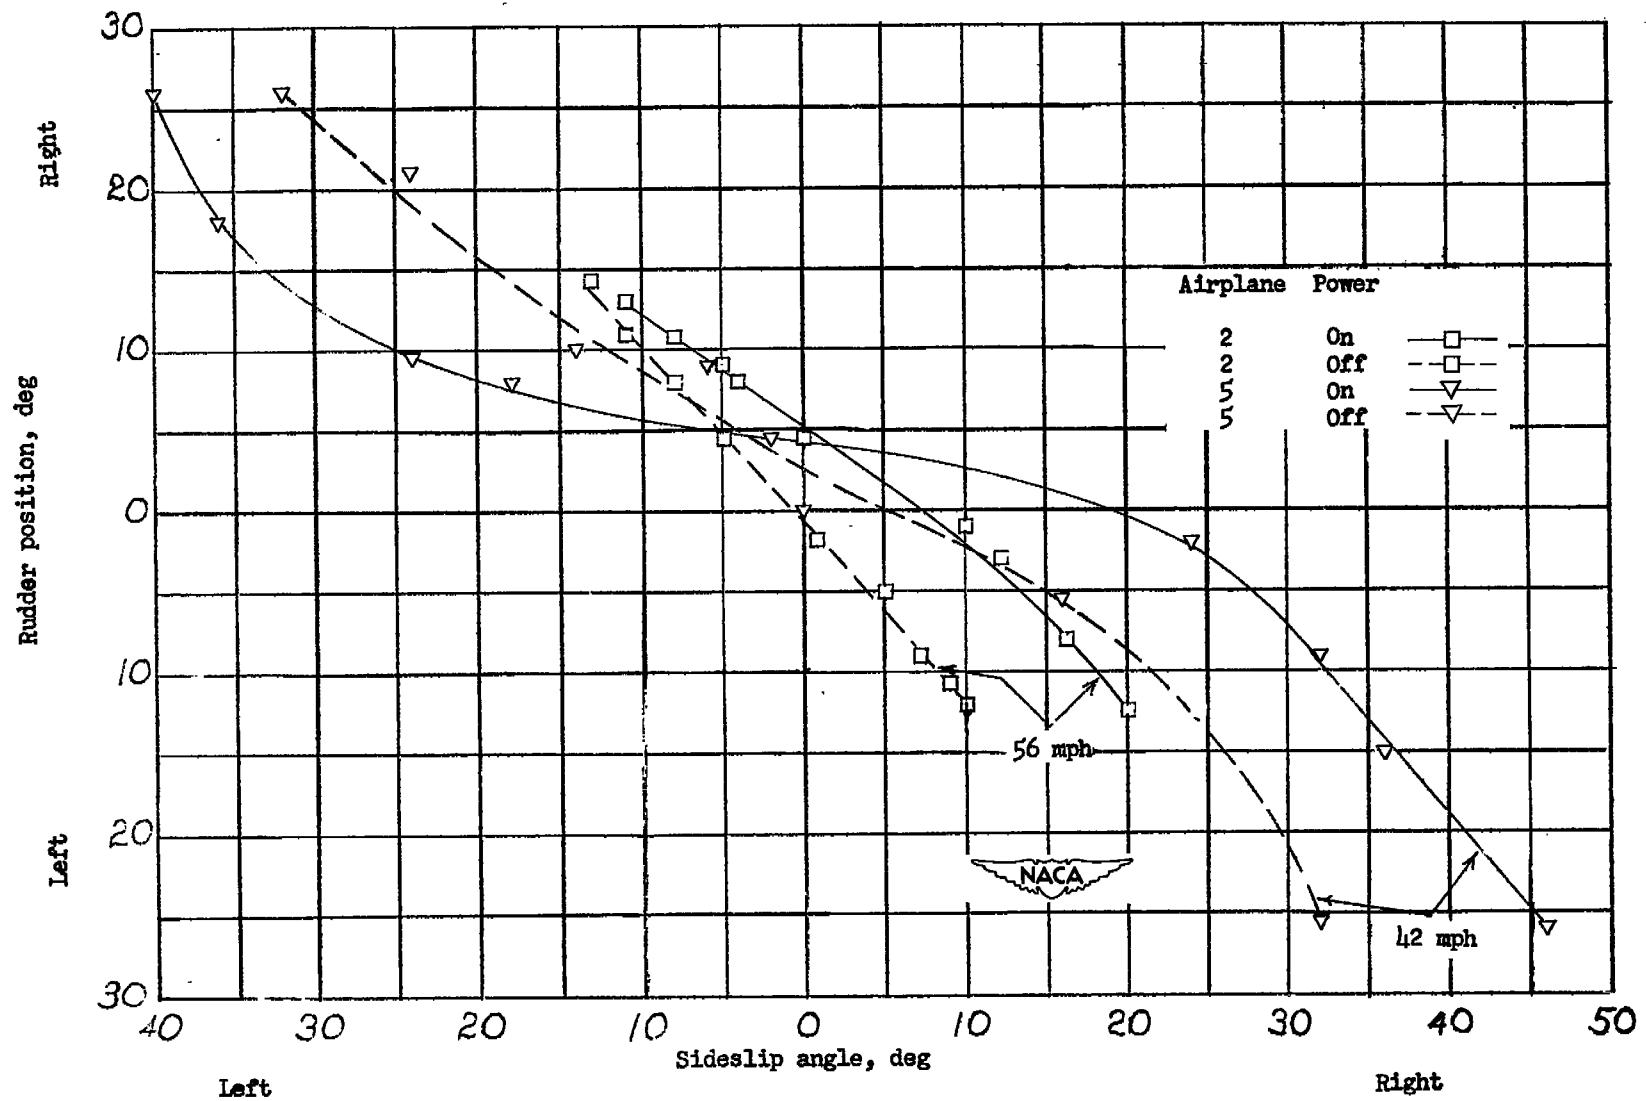
Figure 20.- Relative directional stability of two of the airplanes tested. Airplanes 2 and 5.

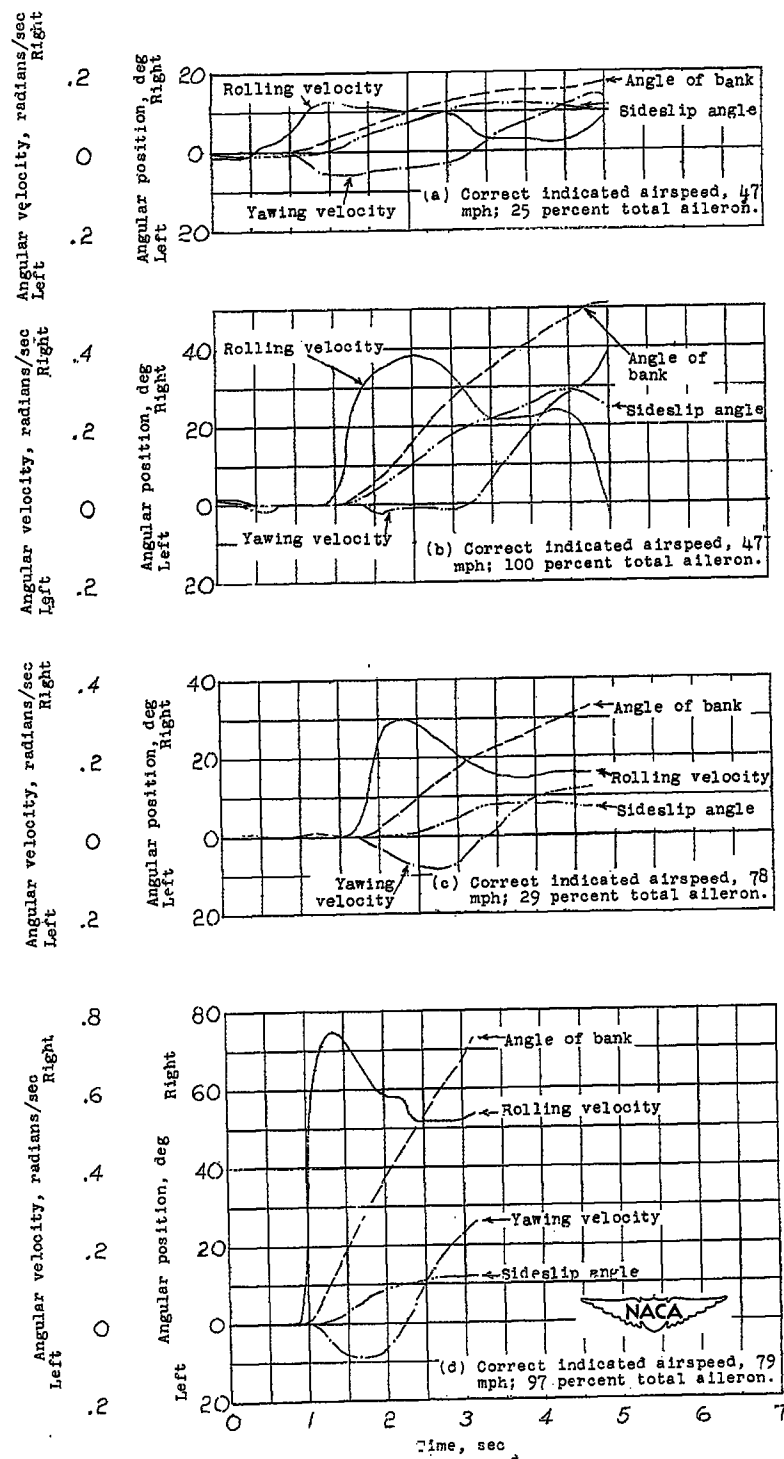
Figure 21.- Time histories of four aileron rolls. Power off; flaps up; airplane 4.

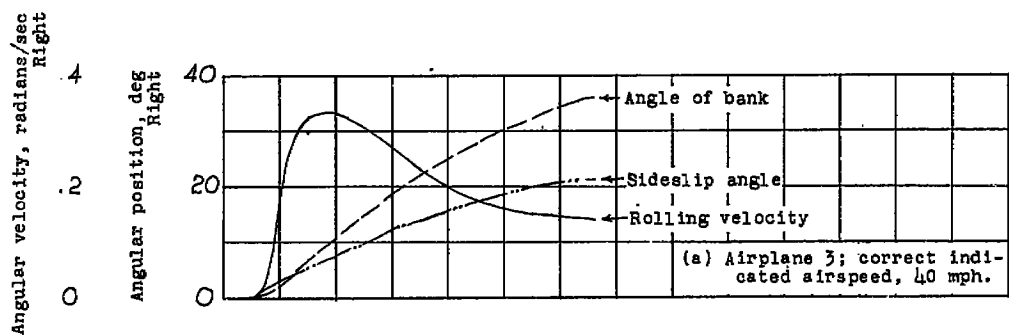
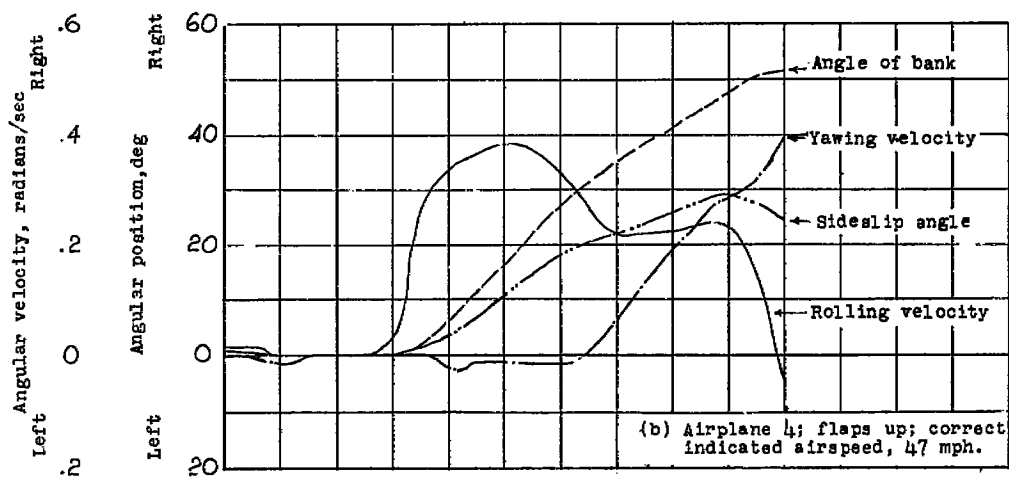
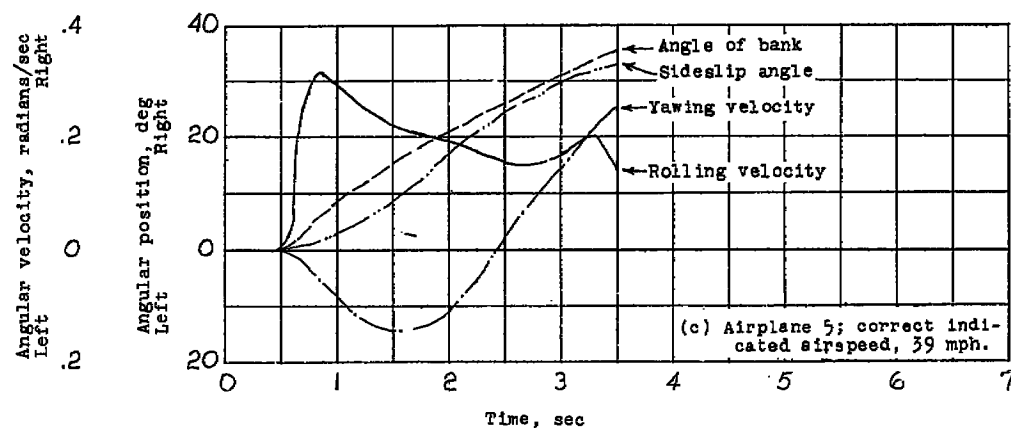
Figure 22.- Time histories of aileron rolls at low speed and full aileron for three airplanes with power off.

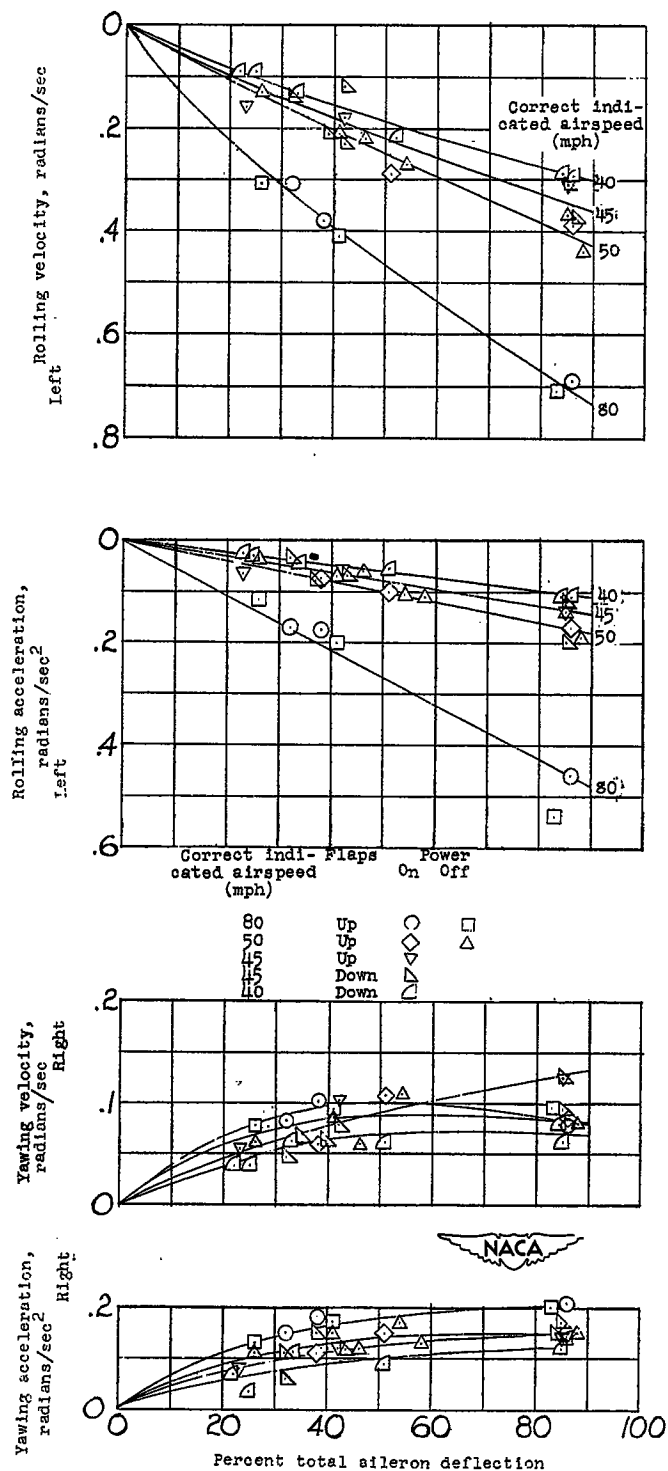
Figure 23.- Aileron characteristics. Airplane 4.

The magnitudes of the rolling accelerations shown in figure 23 are of interest mainly from structural considerations, although the ratio of the rolling acceleration to yawing acceleration is of interest as a measure of the adverse yaw. Changes in power or flap condition for airplane 4 are seen from figure 23 to have no appreciable effect on the aileron characteristics. Likewise, landing-gear position had a negligible effect on the aileron characteristics of airplane 2.

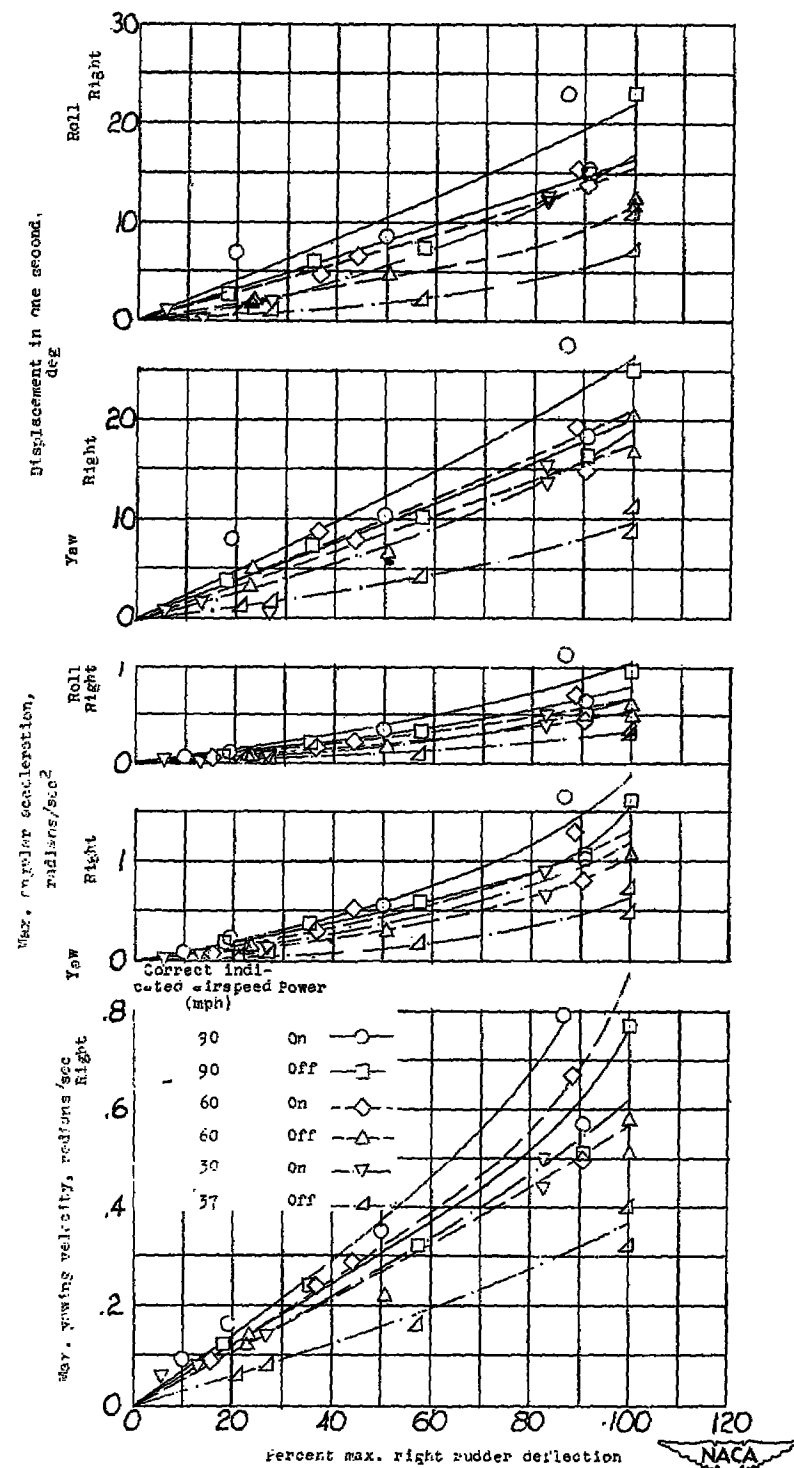
Figure 24.- The maximum yawing velocities, yawing and rolling accelerations, and displacements in yaw and roll produced by abrupt rudder deflections at various speeds. Airplane 1.

The rudder-kick maneuvers shown in figure 24 for airplane 1 indicated a positive dihedral effect in all conditions, as did the sideslip tests, the displacements in roll and rolling accelerations always being to the right for right rudder deflections. The magnitude of the roll due to rudder was in no condition considered to be excessive by the pilot. This conclusion was reached for all airplanes where roll due to rudder was measured.

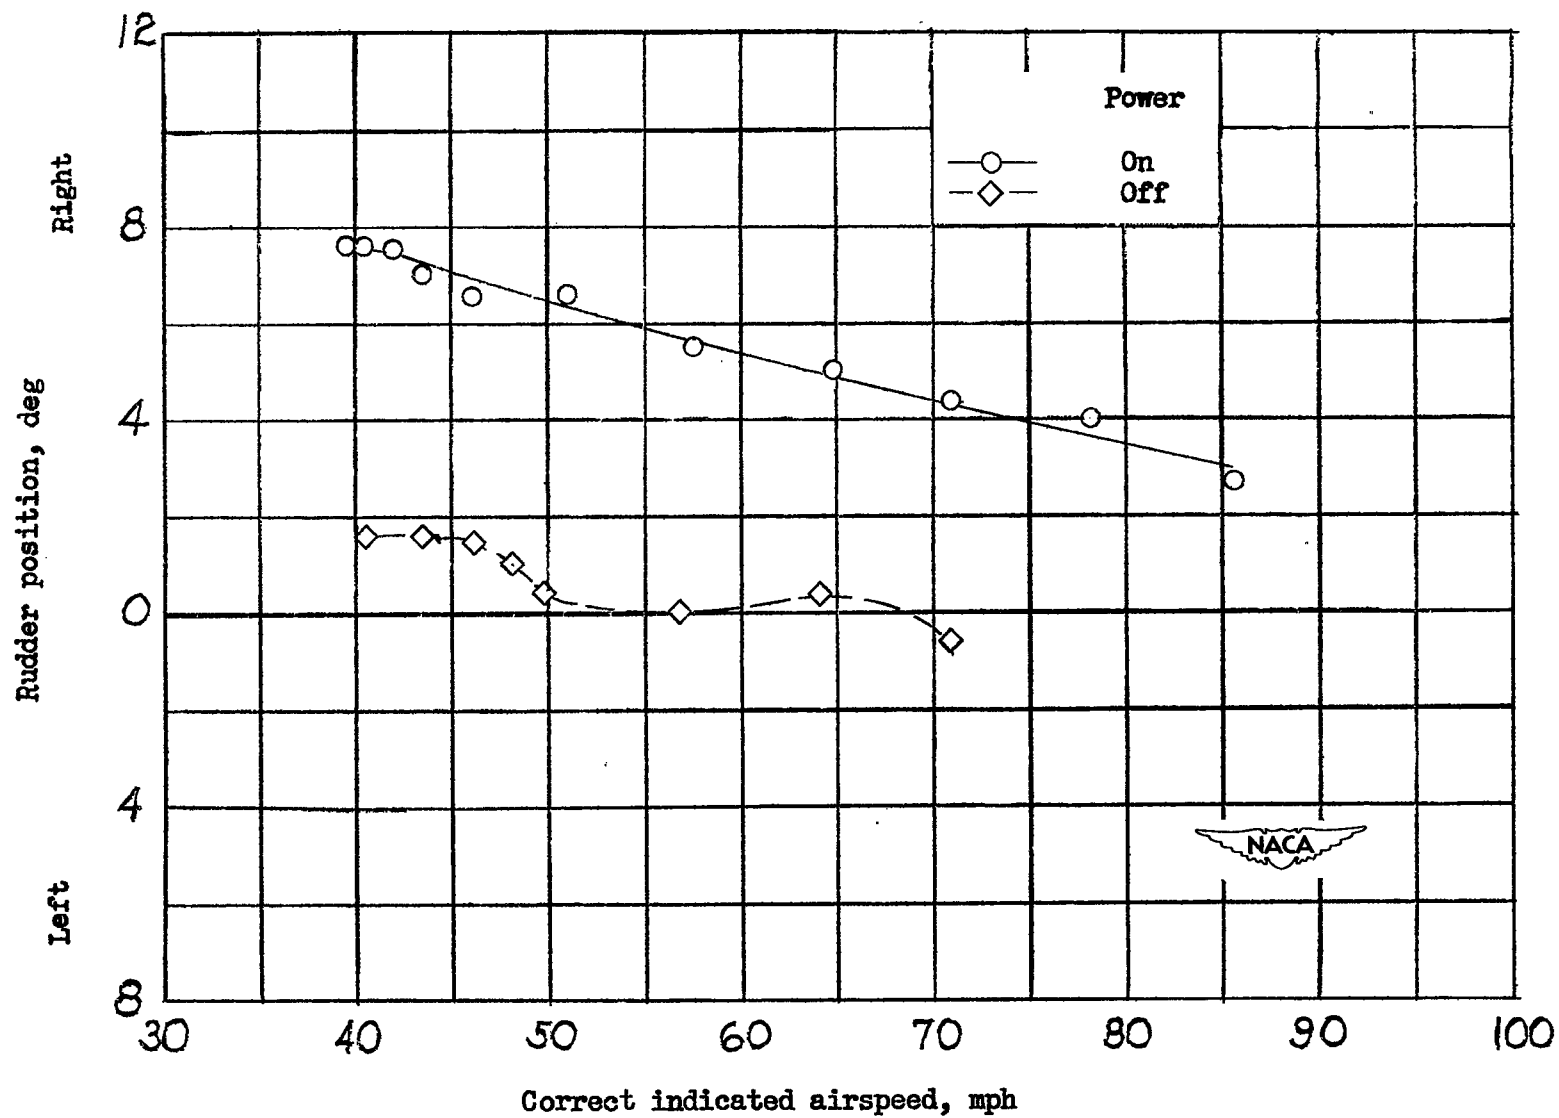
Figure 25.- Rudder positions required for straight unyawed flight at various speeds, power on and off. Elevator tab nose heavy; airplane 1.

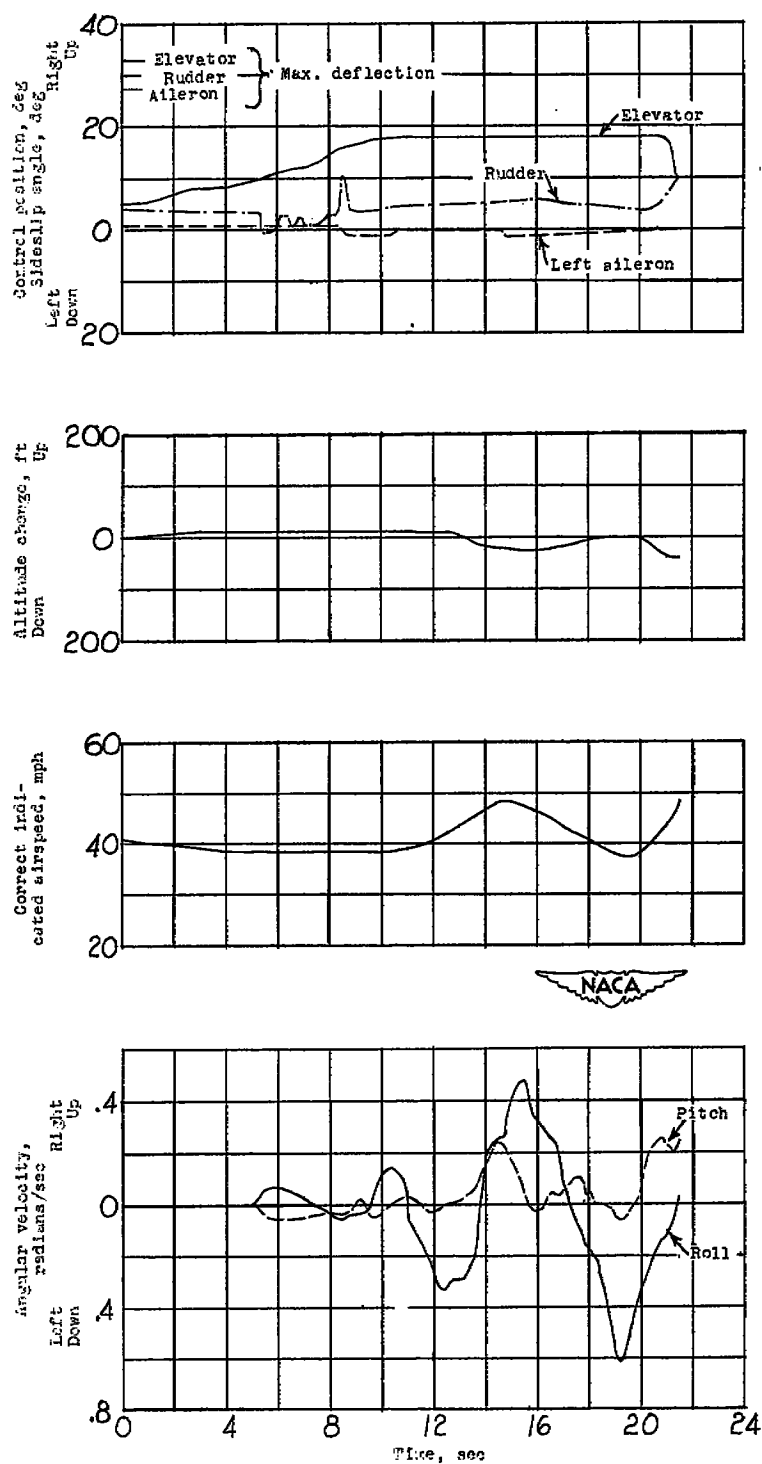
Figure 26.- Development of instability in a slowly produced laterally level power-on stall. Note rapidly diverging oscillation in roll which was not initiated by pilot. Also note the elevator position at which instability started and the pitching that originally tried to relieve stall. Full elevator was not used. Airplane 1.
